PROTECTION OF MOORING BUOYS -
PART I. INITIATION OF FIELD TESTING

30 June 1963

U. S. NAVAL CIVIL ENGINEERING LABORATORY
Port Hueneme, California

Y-R007-08-404

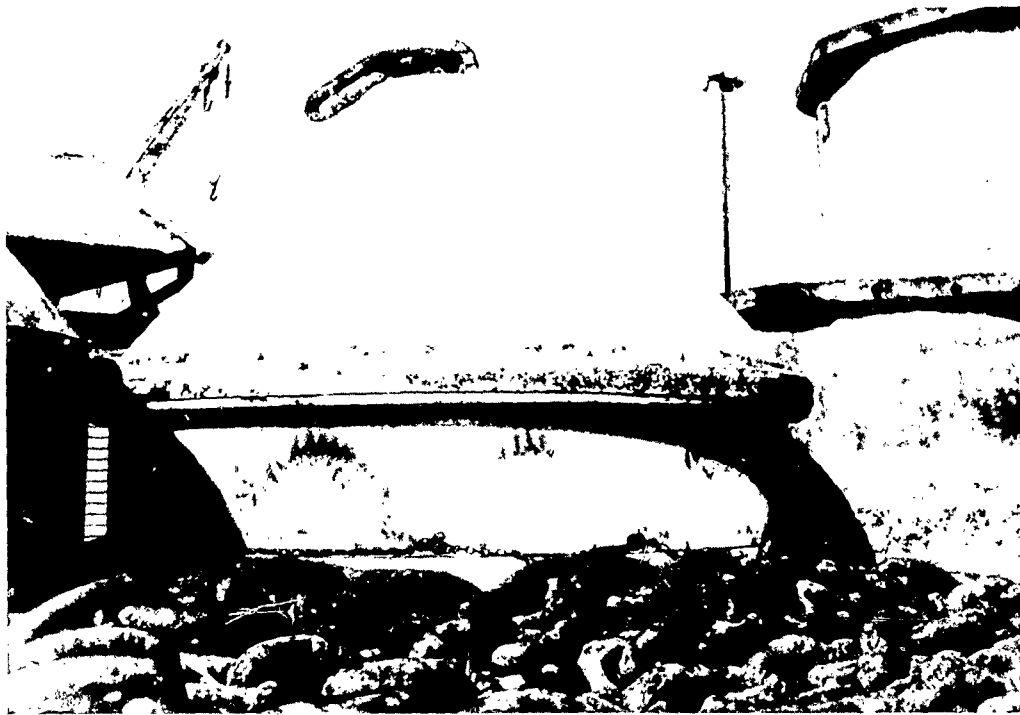
In addition to environment and type of service, a number of other factors contribute to deterioration of protective coatings. These factors include deficiencies in the design of buoys, improper application of coatings, and careless handling of coated buoys, and may to a great extent be minimized by Public Works personnel. Many buoys are equipped with side-hanging chains which apparently were intended for mooring small boats. These rapidly abrade the coating on the sides of the buoys (Figure 2) and should be removed unless specifically required. Many buoys were constructed during World War II, and little attention was given to elimination of crevices, sharp edges, and corners where concentration cells can form and accelerate corrosion. Nonfunctional modifications can be removed from buoys, sharp edges can be rounded, and crevices can be filled where flanges have been tack-welded. Staining of the sides of buoys can be minimized by using coated steel bolts to secure the wooden bumpers.

Figure 2. Buoy with coating on sides abraded by side-hanging chains.

1. Side-hanging chains and other non-functional appendages should be removed from mooring buoys.
2. Pads should be used to protect the coated surfaces of buoys to prevent abrasion during handling.
3. Coated bolts should be used for securing wooden fenders to buoys.
4. Sandblasting and coating application procedures recommended by specification or suppliers should be standard practice.
5. Buoys should be coated as soon as possible on the same day after sandblasting.
6. Coatings should not be applied when the humidity is greater than 85 percent or when the temperature is below the minimum set for the particular coating.
7. Initial inspection of test buoys should occur shortly after the first buoys have been 6 months in service.

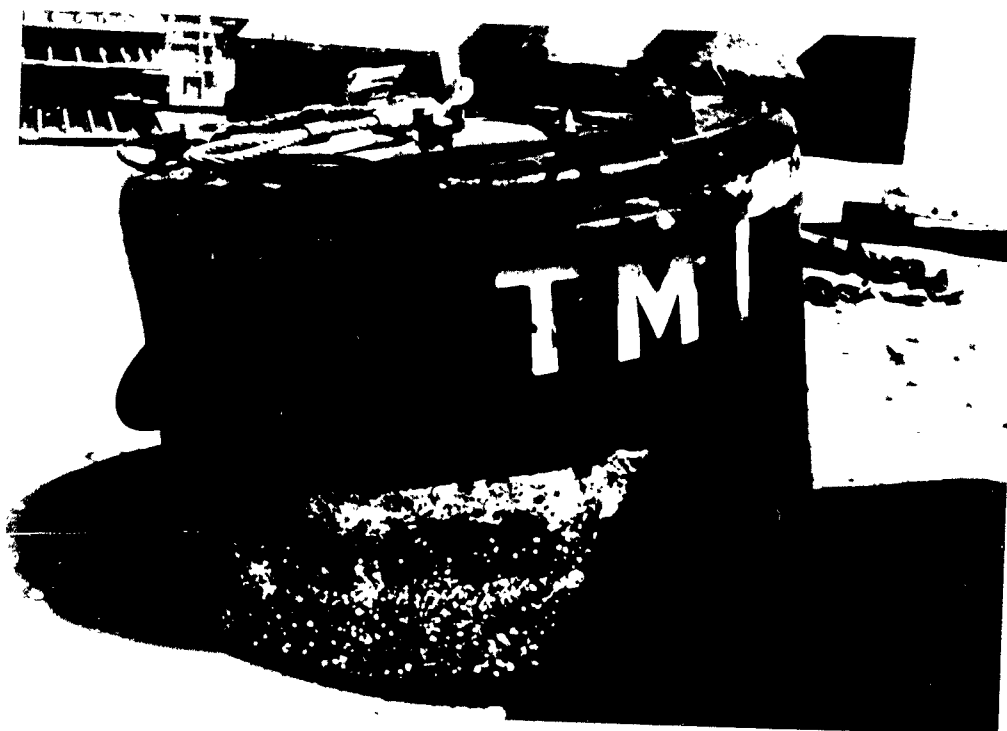
A novel method of preventing corrosion in buoys is through use of plastic buoys. It appears that this type of buoy would be better suited for navigational buoys than for mooring buoys which must take more severe treatment. Splintering of wooden fenders and denting of steel plates is a common occurrence to mooring buoys serving large vessels (Figure 7). Figures 8 and 9 show a small plastic mooring buoy that was tested by San Diego Naval Station PW personnel for BuDocks. The buoy consists of polyurethane foam covered with several layers of fiberglass and one layer of epoxy resin. A tension bar passing vertically through the center of the buoy takes all the load. After 6 months of light service the buoy had to be removed for repairs. Because of its limited buoyancy, it rode very low in the water, and the top railing and rubber bumper were broken loose by overriding moored vessels. PW personnel feel that the buoy might stand up better if changes were made in its design. NCEL has conducted an investigation¹ into plastic pontoons and found that they are rather easily damaged in side launching. Small plastic navigational buoys that were tested by the Coast Guard on rivers suffered structural damage from floating ice.

Figure 8. Damaged, plastic, test, mooring buoy.
